Manhole Inspection Summary

Manhole # S27M__027MH

Location Address: **1111 Washington BD**

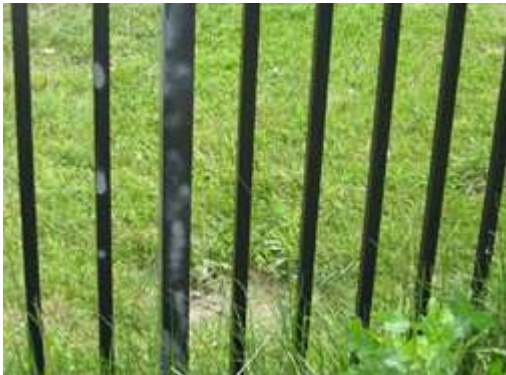
Location View

manhole behind fence in grass

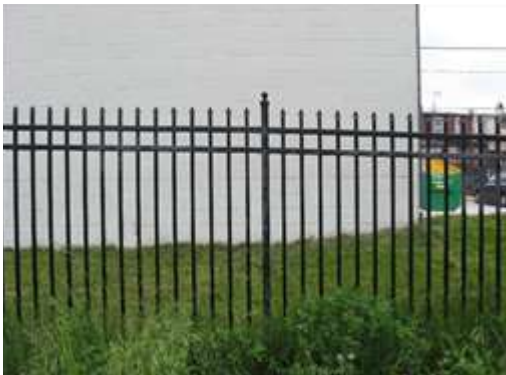
Misc.

additional location view

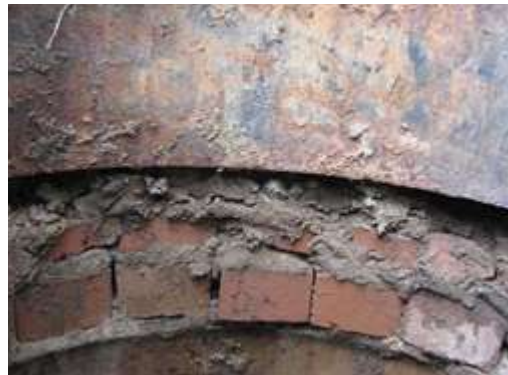
Defect 2

Condition: ☐ Sound ☐ Cracked ☐ Root Intrusion ☐ Loose Brick ☒ **Deteriorated**

gap and missing mortar between frame and chimney

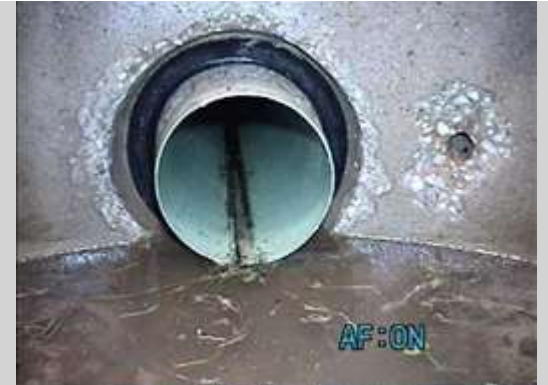
12 O'Clock Outflow

8 in. Circular Gravity Sewer
Pipe Out @ 12 O'Clock

Pipe Material: **PVC** ☐ Pipe Lined

Infiltration: **None** Pipe Seal Cond: **Sound**

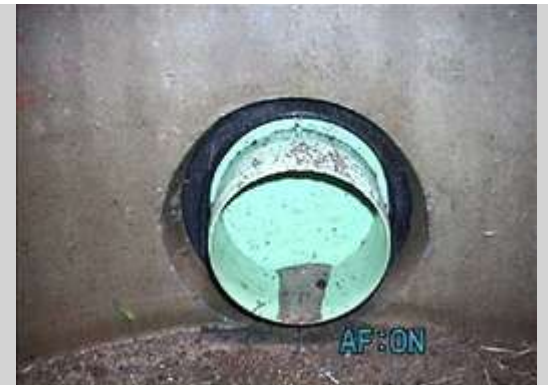
4 O'Clock Inflow

8 in. Circular Gravity Sewer
Pipe In @ 4 O'Clock

Pipe Material: **PVC** ☐ Pipe Lined

Infiltration: **None** Pipe Seal Cond: **Sound**

Connects To: **Stub connection / abandoned**

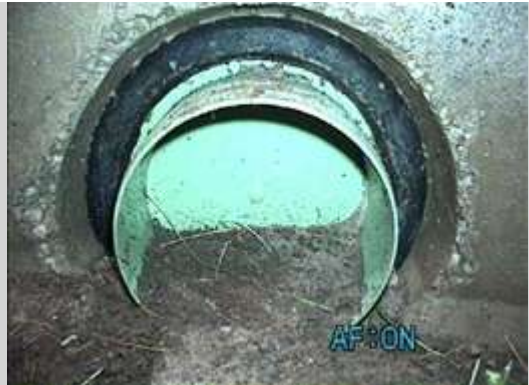
9 O'Clock Inflow

Pipe In @ 9 O'Clock

Pipe Material: **PVC** ☐ Pipe Lined

Infiltration: **None** Pipe Seal Cond: **Sound**

Connects To: **Stub connection / abandoned**
